FEDERAL RAILROAD ADMINISTRATION

**New York & Atlantic Railway
Focused Safety Review
September 23, 2016**

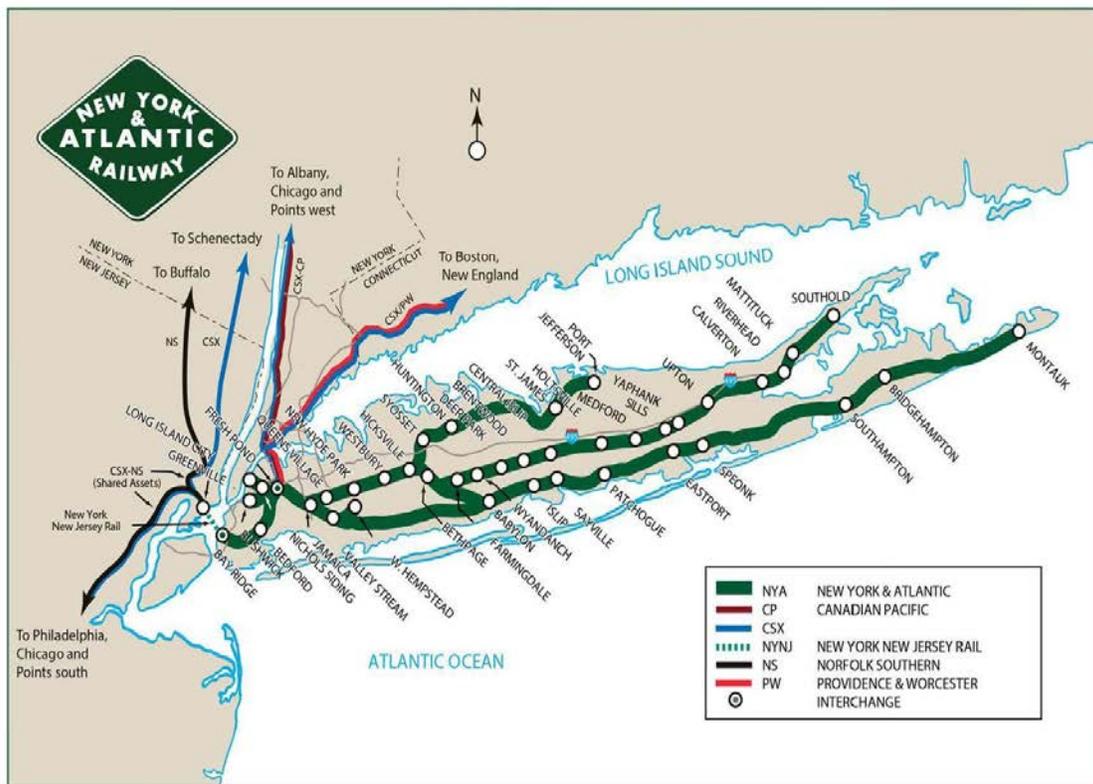
Figure 1: New York & Atlantic Railway

NYA began operating in May 1997 when the Long Island Rail Road (LIRR) privatized freight train operations on its lines. NYA is owned by Anacostia Rail Holdings and operates on the busiest commuter passenger system in the United States. NYA has its own equipment and crews, but operates over LIRR's rail infrastructure. NYA employs a staff of approximately 41 and operates over 269 miles of track on Long Island, New York. NYA transports municipal solid waste, construction and demolition material, lumber, paper, building materials, plastic, aggregates, food products, and recyclables with an average annual volume of approximately 28,000 carloads (See Figure 1 for NYA map).
